### *Level of Documentation*

# Chapter Six

## Upgrading Building Systems

## Commercial Rehabilitation of a Historic Building

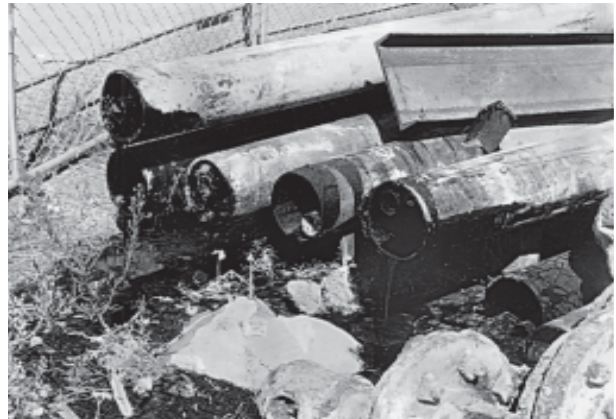
**Figure 2.13**  
Failure to determine that existing structural steel pipe columns were filled solid with tar required complete redesign of structural reinforcement during construction.  
Photo credit: Robert Vail Cole
